WINTER 2017-2018 NEWSLETTER

THE GARCIA HOUSE EASEMENT: AN INTERVIEW WITH NEW HOMEOWNER NAOMI BARNES

El Zaguán

A YEAR IN THE LIFE

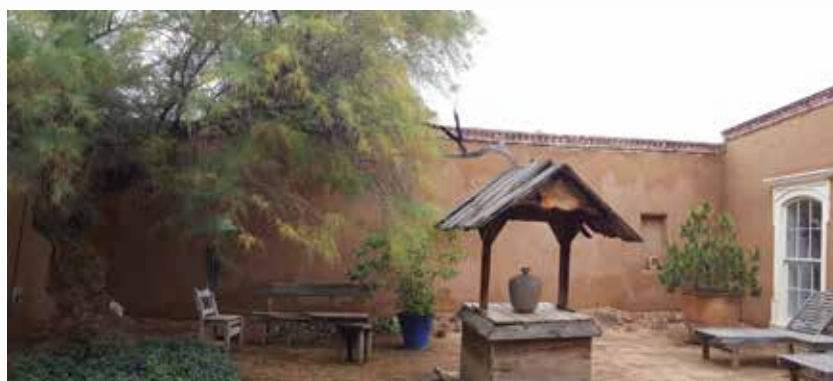
Image page 3, Garcia House west façade. Above, east façade from Vigil House courtyard. Below, Garcia House east façade.

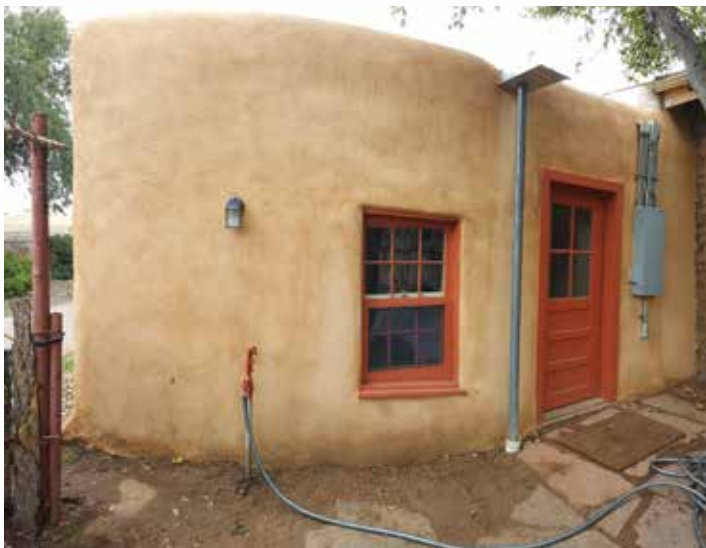
Image above Garcia House south façade.

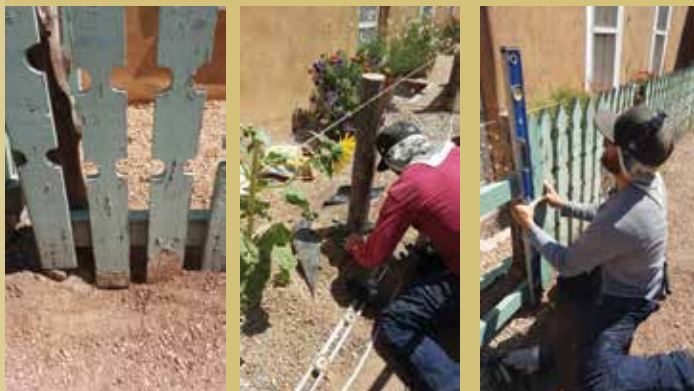
While there is constant work happening at El Zaguán and all of the properties the Historic Santa Fe Foundation owns, several larger scale endeavors were undertaken in 2017. Perhaps the most immediately visible to the public strolling down Canyon Road was the work done on our iconic turquoise fence. For many years, it has encroached on the sidewalk, leaving only a narrow path for single file pedestrian traffic – or, more accurately, for pedestrians to walk in the street. With ever increasing traffic on the street, we made the decision to push the fence about 32” toward the building, which allows people to stay safely on the sidewalk while maintaining a privacy buffer for our resident artists.

To move the fence, HSFF restoration specialist Bobby Wilson disassembled it into its base components of slats, bars and posts. Before beginning work, the Foundation sought permission from the City of Santa Fe Historic Preservation Division for the change, which was granted with the understanding that as much historic material as possible would be retained, as would the general appearance and paint color of the fence. To that end, we sourced posts to match the few with rotten bases – unpeeled latillas as one has seen in ceilings and coyote fences all over New Mexico for generations. Latillas are thin compared to the larger vigas which make up traditional roof structures in the region, generally 3-6” in diameter, and made of branches or trunks of trees which grow in the area such as spruce, pine and juniper. These latilla posts were set in concrete bases to keep them standing straight in the earthen sidewalk.

Before the bulk of the fence could go back up, each post had to be assessed for rot, sanded smooth and repainted. Unsurprisingly, many of the posts had some degree of rot at the base, where they were most likely to get wet from the sidewalk, have snow packed against them, and generally soak up moisture through the end grain of the wood, which acts like a bundle of closely packed straws to absorb and release water. Most of these posts were retained with only a small section of the bottom cut off – this both removed the rotted area and made space for a gap between the sidewalk surface and the bottom of the slats, which will help reduce this problem in the future. Still, some posts did need to be replaced, and Bobby diligently recreated their curvy cutouts.

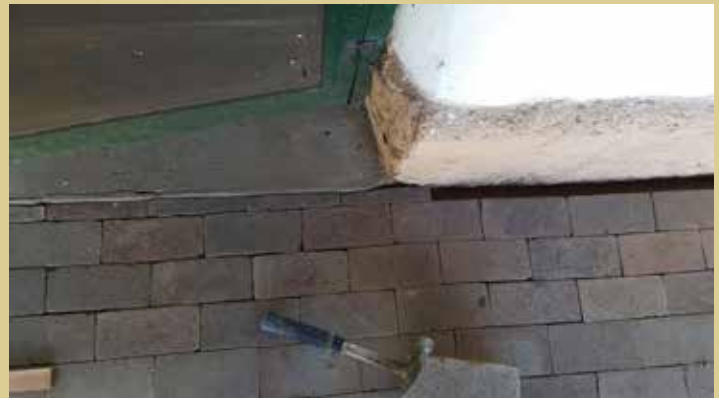
“charming” historic material that proved challenging to maintain was the small retaining wall along the edge of this walkway. Because the brick is set in sand, there needs to be something solid along the edge to hold the sand in place. Until recently, this was a stacked stone wall with a stucco coating. It was lumpy, uneven, and because the stucco frequently cracked off of the rocks, not particularly attractive. Between the deterioration of the rock wall and various small animals such as squirrels digging under the brick, the walkway had become an uneven tripping hazard, particularly in the area surrounding an old well house midway down the path.

Research has not satisfactorily answered whether there truly was a functioning well in this location – it seems an odd choice, only a few feet from what would have been a bedroom, right in a main path. Regardless, the wooden well house has been in the same location since at least the 1930s. It may have been a nostalgic decoration when it was installed, or it could have been moved from a working well elsewhere on the property. Either way, it had no sub-structure support beneath it like the rest of the path, and because of its placement there was a break in the stone wall, which allowed sand to gradually pour out and the bricks to sink. The decision was made to move the well house so that the path could be made continuous and even.

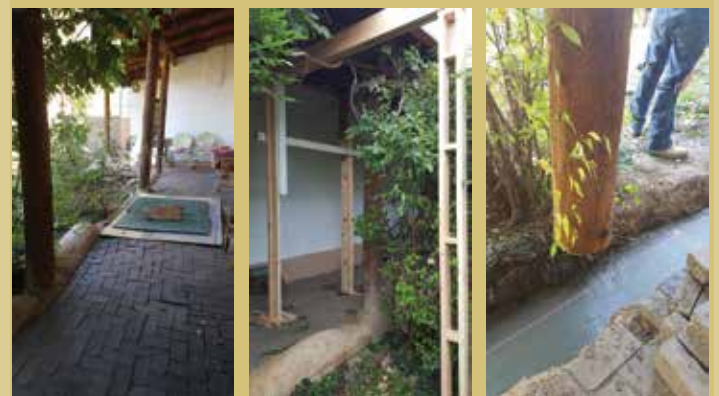
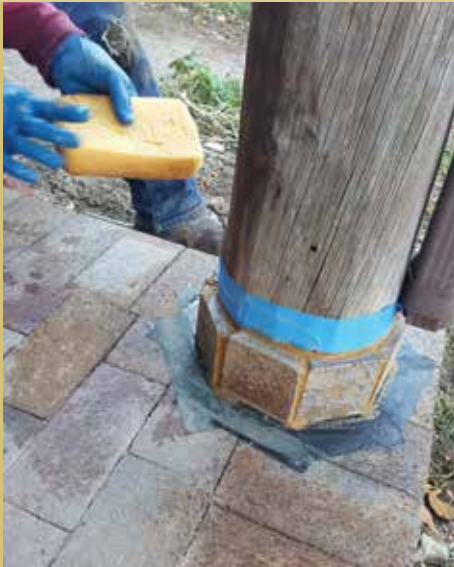
Before undergoing the rebuilding of this walkway, the portal over it needed to be supported. Again, Bobby Wilson stepped in and built a sturdy, robust wooden superstructure to take the load off the wooden posts while their bases were replaced. A skilled team of bricklayers were hired to first remove the remnants of

the stone and stucco piles. In their place, they dug a trench and poured a concrete and CMU footing. This provides a stable, even edge for the walkway. Once this was built, leveling the sand base and setting brick over it was a relatively simple endeavor. As a finishing touch, Bobby cut brick

bases and placed them beneath the columns.

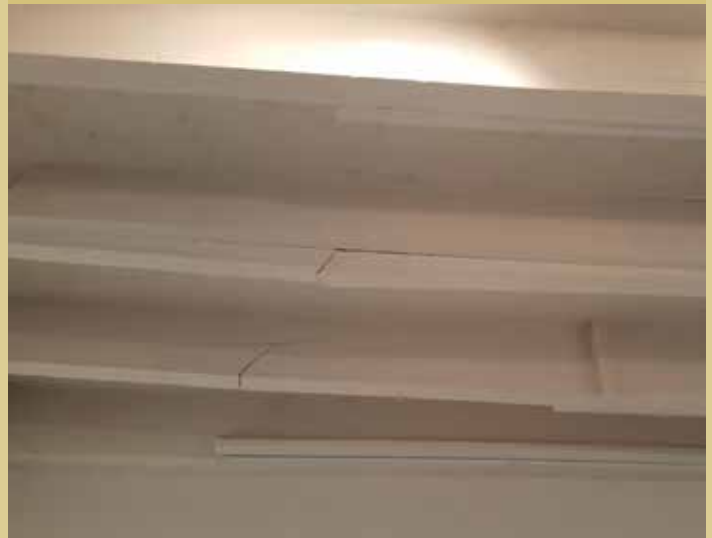
While all this work has been happening, plans for the next major repair have been underway. Several beams at the west end of the sala, the room in HSFF's offices where we host our monthly art exhibitions and Salon talks, have sagged and cracked. They have been repaired before, with thick boards attached to the sides of the cracks to take some of the strain from them. These repairs have however not completely solved the problem. El Zaguán has an earthen roof, like many older buildings in the area, meaning there is packed earth in depths ranging from approximately 12" to 24" above the ceiling. Perhaps at some point in the past, a leak caused the dirt in that area to become heavier and heavier as it became saturated with water. Once the beams are damaged, they can have trouble holding even an average load of dry dirt.

plan thus far is to support the beams with ceiling jacks and "sister" them with high strength microlam beams on either side. Microlam is a laminated veneer lumber product made up of thin sheets of wood which are sandwiched with a strong glue. These will run the full width of the sala, just like the existing beams, will be bolted together through the existing beams to take the load from them. While microlam is not a traditional building material, its strength allows us to retain the original building material, the 1930s beams installed by Margretta Dietrich, rather than replacing it in kind. It also minimizes disturbance to the rest of the building, as the work can be done from inside rather than removing the roof and digging out sections of the walls.
